Proceedings of the 44th Conference on
Computer Applications and
Quantitative Methods in Archaeology

On roof construction and wall strength : non-linear structural integrity analysis of the Early Bronze Age Helike Corridor House

On Roof Construction and Wall Strength: Non-Linear Structural Integrity Analysis of the Early Bronze Age Helike Corridor House

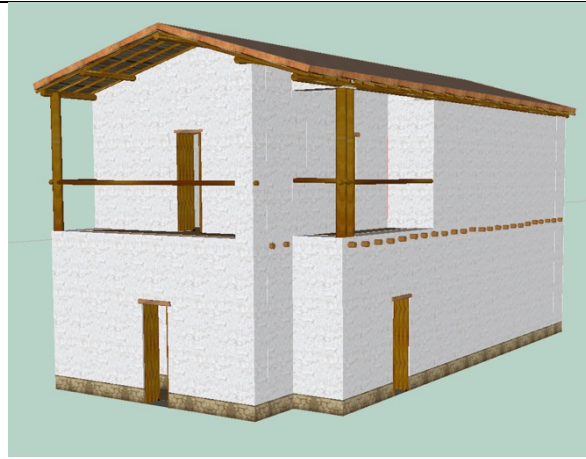
Modelled Corridor House in SketchUp

Imported model into ANSYS, roof removed

Figure 1: The Helike Corridor House model. The roof was replaced by its equivalent weight in the simulation studies
